CAUSES OF FAILURE OF AIRSHIP SHEDS.

I. COLLAPSE OF AIRSHIP SHED A IN NIEDERGORSDORF.

II. SUCTION EFFECTS OF WIND ON ROOF OF AIRSHIP SHED

CAUSES OF FAILURE OF AIRSHIP SHEDS.*

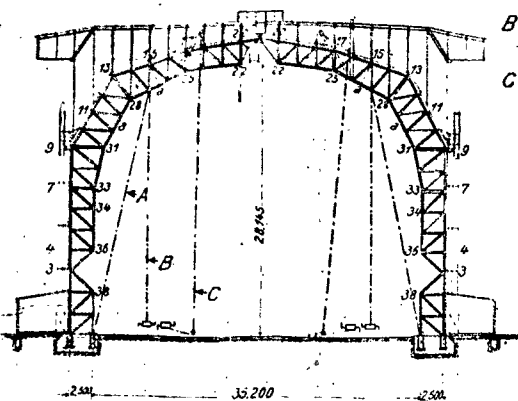
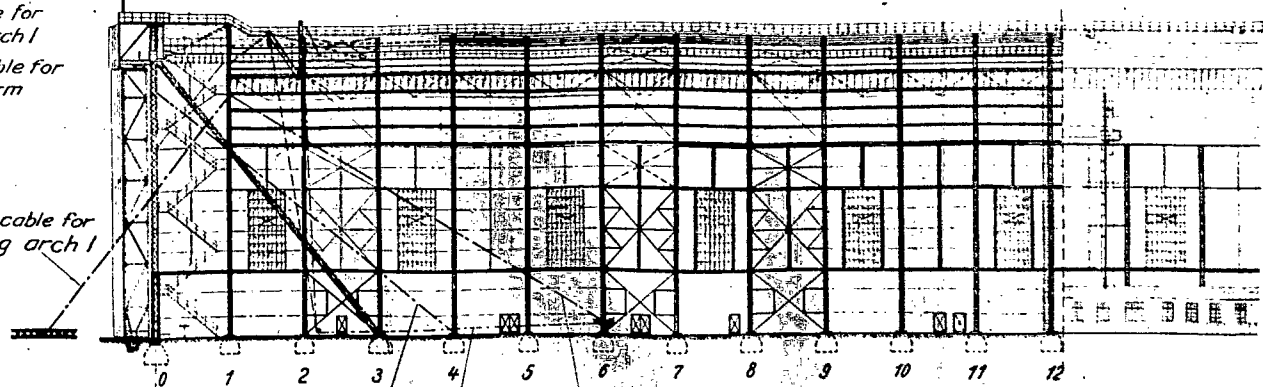
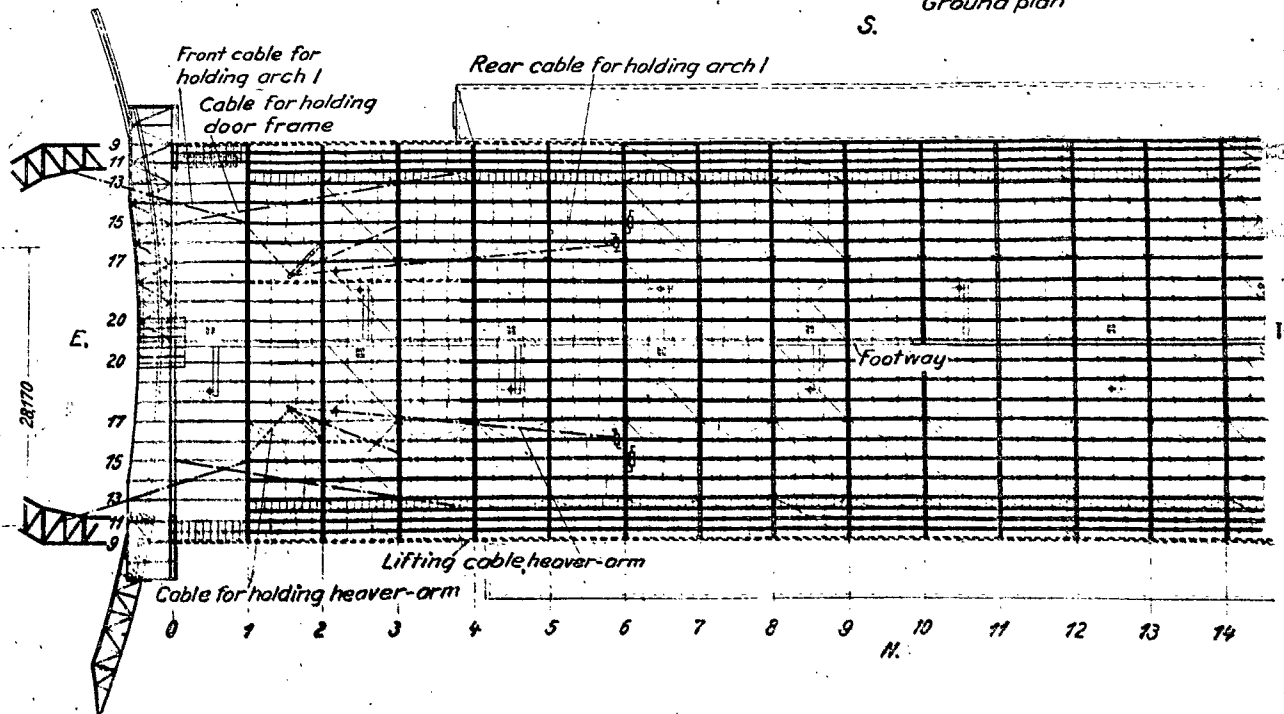
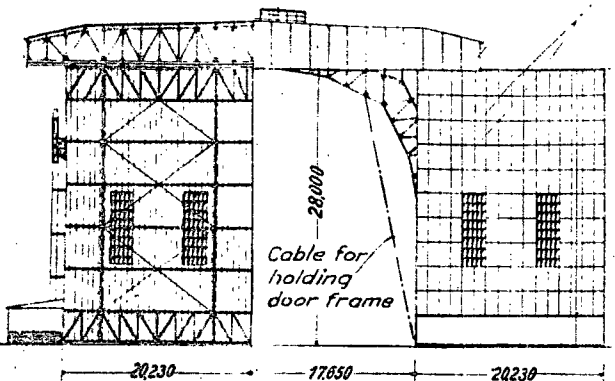
The roof covering had been partially removed. The roof supports were three-jointed arches with ridge-pole joint and buttress joints. Fig. 1 shows all the structural parts which had not been removed at the time of the collapse. There had already been removed both end-doors and guides, all supports between purlins 9 and 9, and the longitudinal brace in the side walls as far back as arch 7 and in the rear as far forward as arch 17. Under the roof covering, between arches 2 and 3, the cross-braces between purlins 17 and 17 had been removed and it is highly probable that all of them had been loosened. Of the

longitudinal girders between the upper and lower arches, all the upper members between purlins 13 and 13 had been loosened and the lower members were mostly bent and twisted by the weight of the upper members which, with their braces, were tilted and hanging sidewise. Lastly, the ridge-pole and the footway under it had been removed to about the middle of the shed, so that the ridge joint was no longer braced laterally. The buttress joints still held, because the walls below them were lined with masonry and the stays had not been removed.

In the condition shown in Fig. 1, all the arches had been detached to such an extent that their security was endangered. Relatively small eccentricities of the columns or spans or of the lateral forces could have easily caused them to break down. A strong gust of wind would have perhaps sufficed. The most endangered points, namely the top ends of arches 1 to 3, were subjected to considerable additional stresses, since heaver-arms were attached to the side of arch 2 for lowering the pur-

On south side, braces 20-22 and 17-25 entirely removed
 " north " " 20-22, 17-25 and 15a "
 " south " at 15-a, upper braces loosened
 " " " 13-28, top member "
 " north " " 13-28, " " "

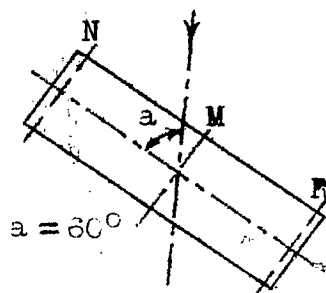
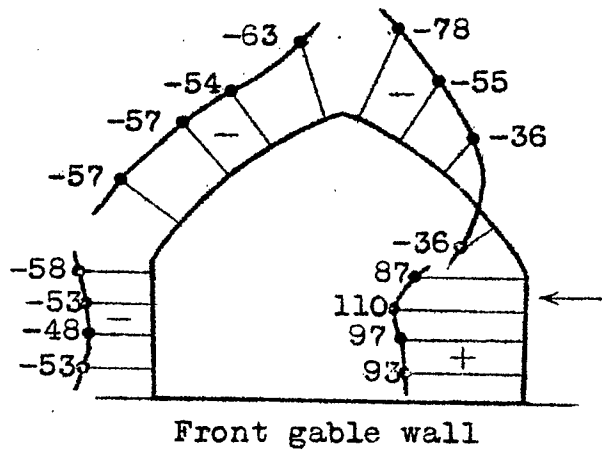
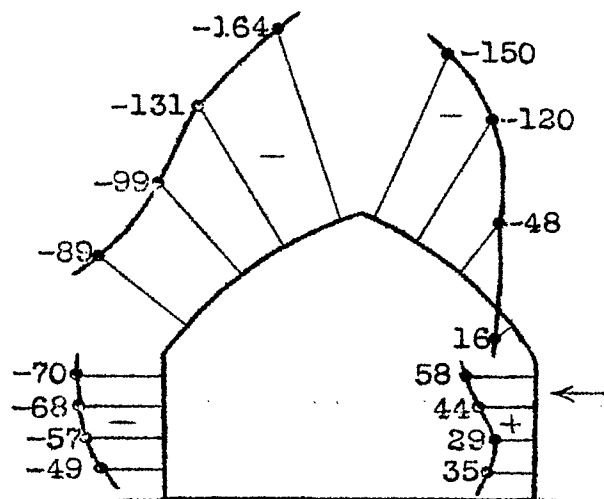
Fig.2 Air pressure distribution on model of airship shed, according to Eiffel.
Plate XXXI of Atlas

Fig. 2 shows the distribution of the pressure on the middle section and on the front gable wall of a shed model, created by an air stream with a velocity of 40 m/sec striking it at an angle of 60° . Toward the gable wall, on the windward side of the roof, the negative pressure decreases somewhat, though the manner of distribution is not changed.

It is seen that the location of the plates blown off is at the point of greatest suction and that their weight per square meter corresponds to the negative pressure in the Eiffel diagram. We may therefore conclude that the wind had a velocity of about 40 m/sec at the time of the disaster.

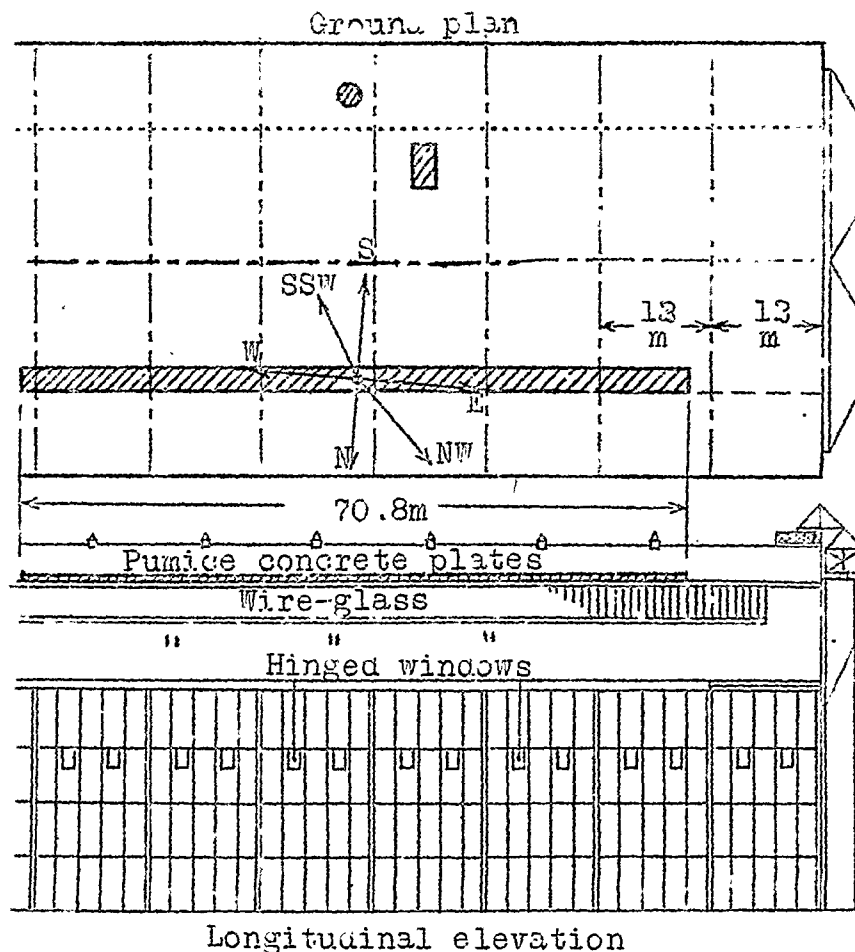
The storm struck the airship shed at an angle of somewhat less than 45 degrees, tore off a row of concrete plates about 70.8 meters long half-way up the roof, blew them over the ridge-pole and deposited them on the shed in the lee of the airship shed. The distance the plates were carried varied between 45 and 60 meters.

Fig. 3 Ground plan and longitudinal elevation of damaged portion of airship shed "Nord" in Staaken. The cross hatching indicates damaged portions of shed roof.

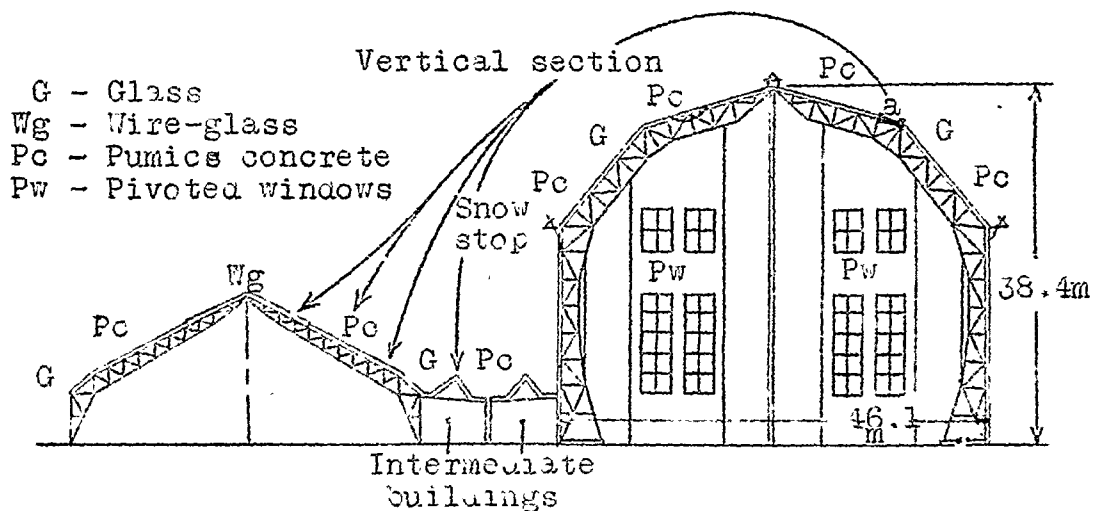
Each plate measured 2.36 x 0.6 meters, thus having a surface area of 1.416 square meters. With a unit weight of 80 kg, this gives a weight of about 57 kg per square meter. The total weight of the plates torn off is about 10,000 kg.

Fig. 4 Storm damage to airship shed "Nord" (right) in Staaken Dec. 18, 1921. Middle shed on left. At "a" the concrete plates were torn off by the storm.
